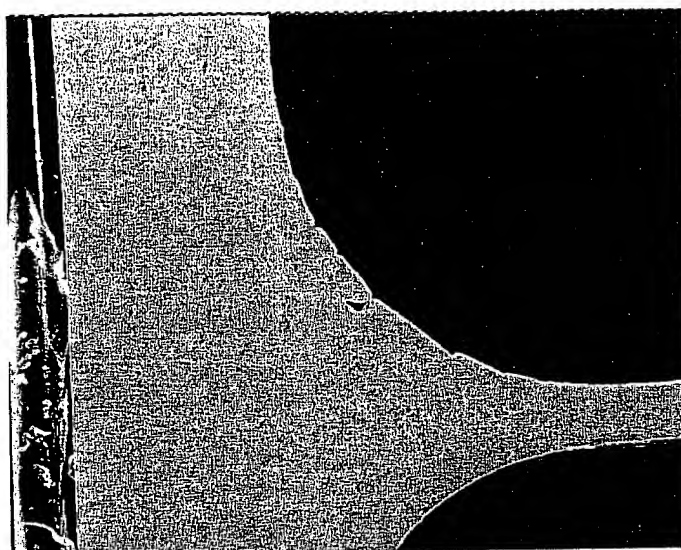
Fig. 5

Figure 5: Braze Joints of Cu/Ni/SS, Brazing Temperature 1130°C
